FHWA- INVESTIGATION OF THE EFFECTIVENESS OF EXISTING
RD- GE DESIGN METHODOLOGY IN PROVIDING ADEQUATE
73-13 STRUCTURAL RESISTANCE TO SEISMIC DISTURBANCES.

Phase I: Literature Survey

T. Iwasaki, J. Penzien, and R. Clough

November 1972
Final Report

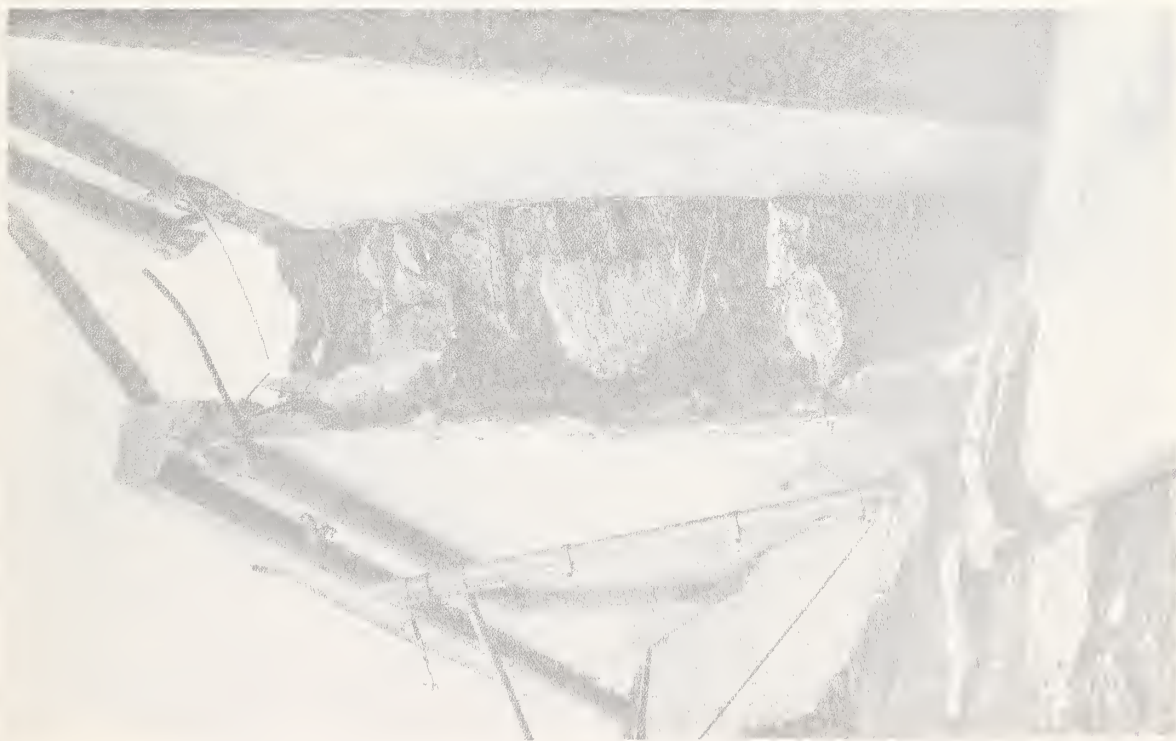
Photo. 2.117 Damaged wing wall of
abutment - Roxford Street
Undercrossing at Foothill
Freeway

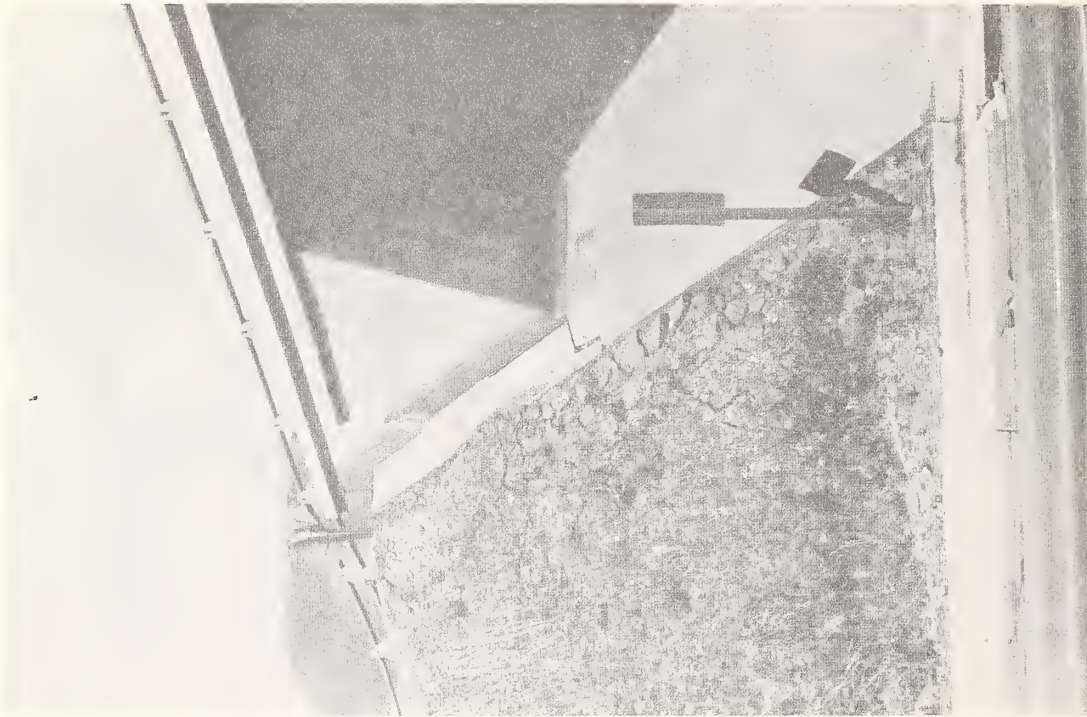
Photo. 2.119 Damaged concrete apron on
abutment slope - Roxford
Street Undercrossing at
Foothill Freeway

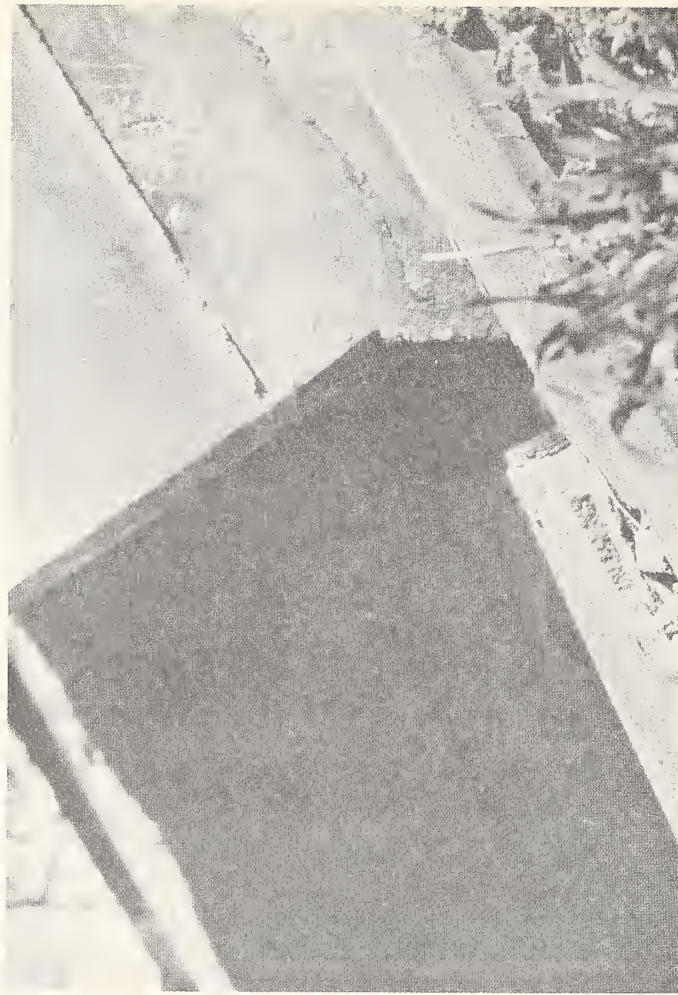
Photo. 2.120 Damaged concrete apron on abutment slope -
Roxford Street Undercrossing at Foothill
Freeway

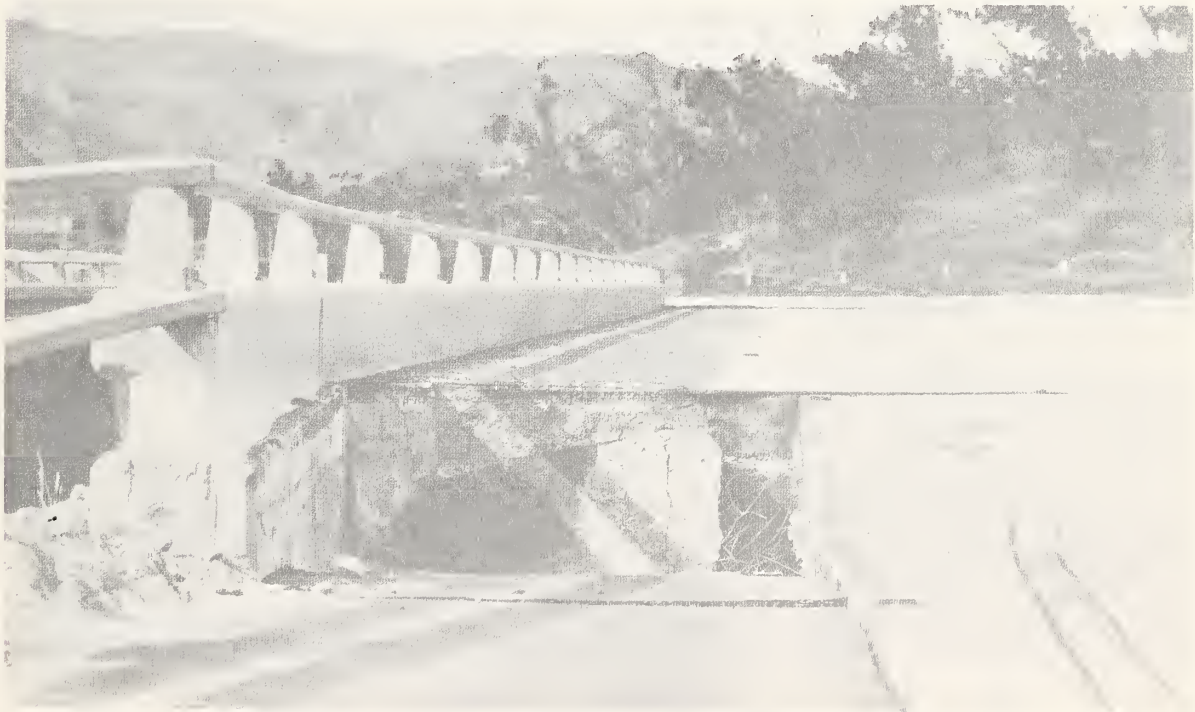
Photo. 2.122 Differential settlement of backfill at
abutment - Roxford Street Undercrossing at
Foothill Boulevard

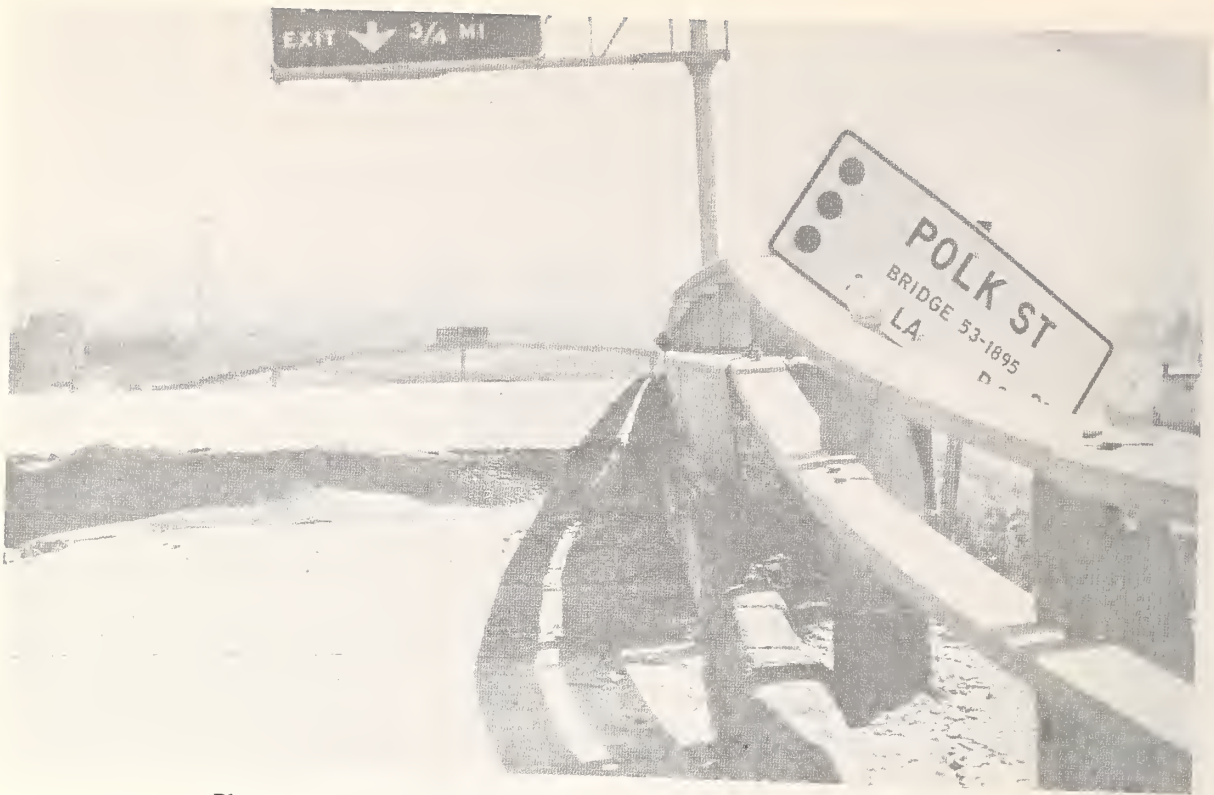
Photo. 2.123 Differential settlement of backfill at abutment - Polk Street Undercrossing at Foothill Freeway

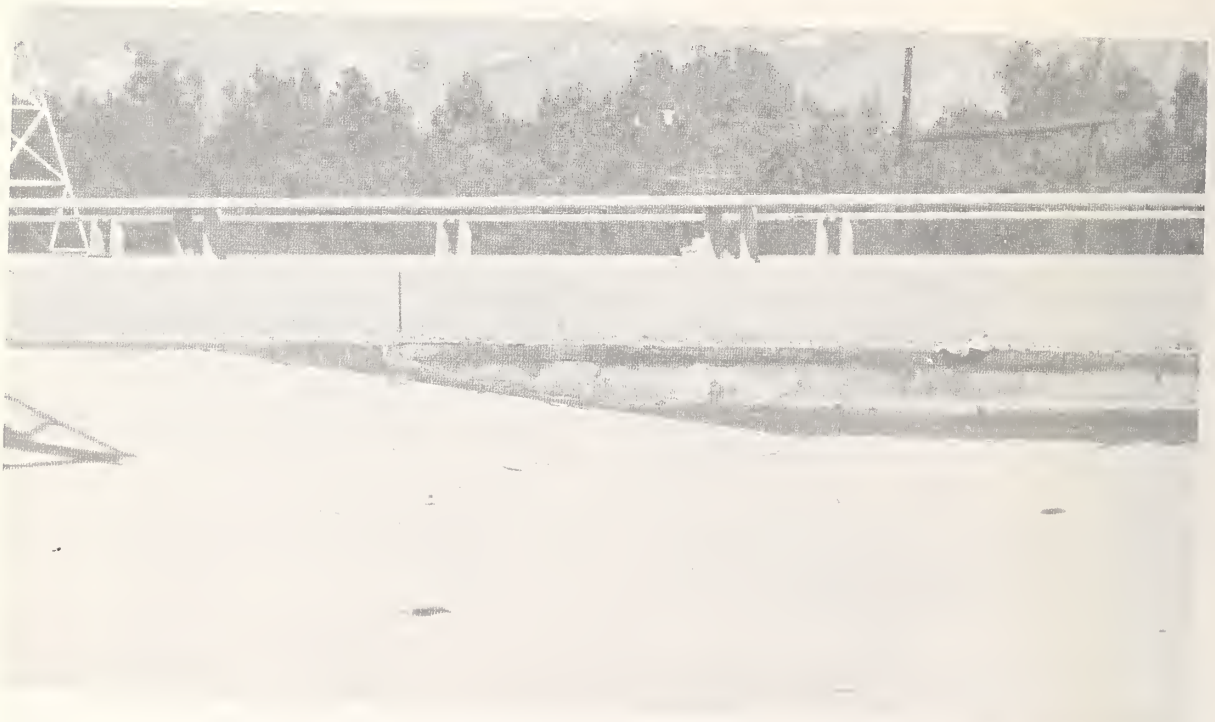
Photo. 2.124 Differential settlement of backfill at abutment - Polk Street Undercrossing at Foothill Freeway

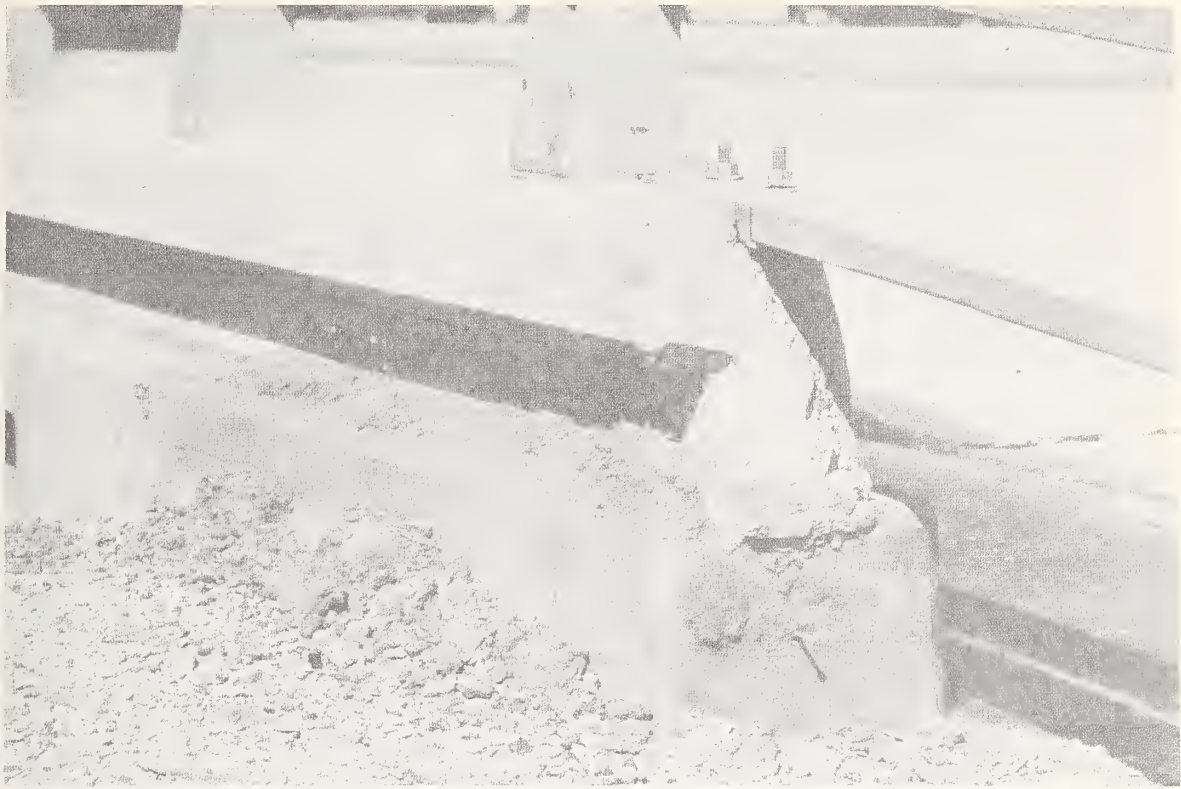
Photo. 2.125 Differential settlement of backfill at
abutment - Polk Street Undercrossing at
Foothill Freeway

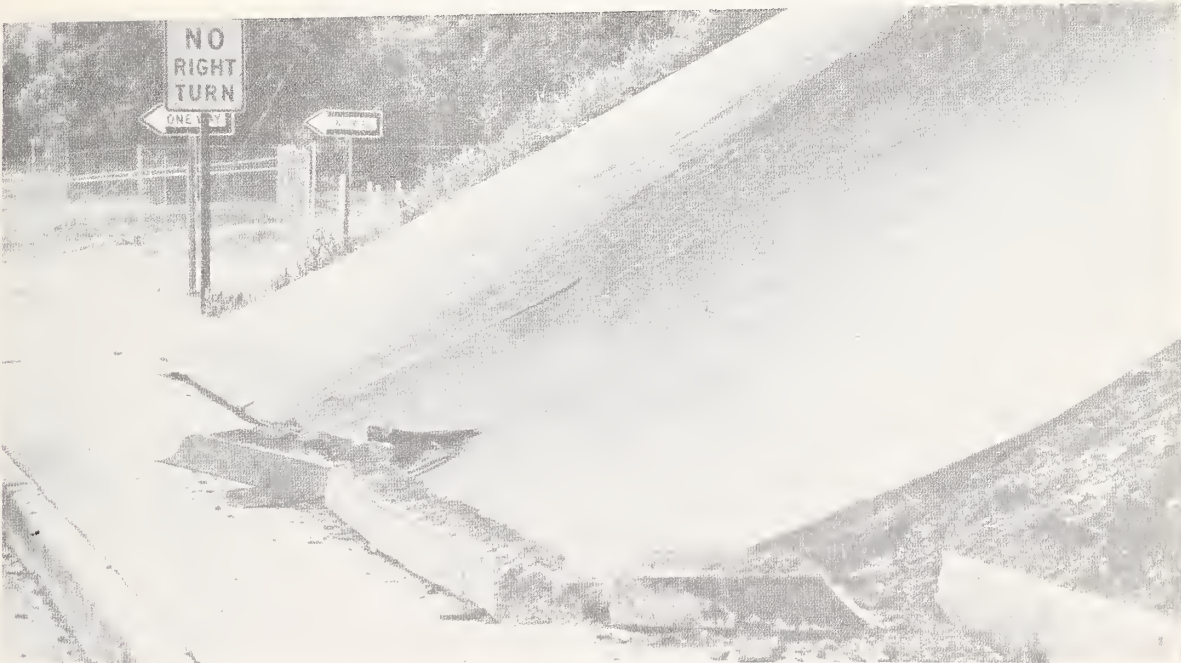
Photo. 2.126 Differential settlement of backfill at
abutment - Polk Street Undercrossing at
Foothill Freeway

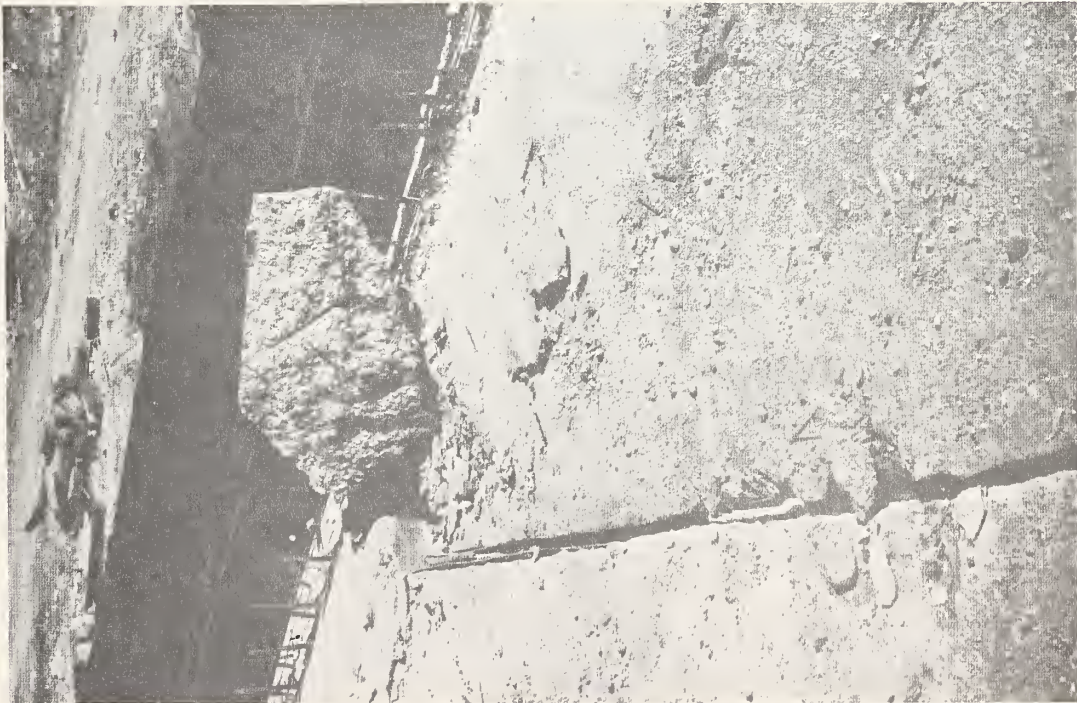
Photo. 2.145 Pounding damage at expansion joint - Santa Clara Overhead Crossing on State Highway 14
